Bolinas Lagoon Ecosystem Restoration Feasibility Project

IV Conceptual Littoral Sediment Budget

MEMORANDUM

DATE: July 11, 2005
TO: Al Paniccia
COMPANY: USACE
FROM: Don Danmeier and Philip Williams
COPY TO: Bill Carmen
RE: Conceptual Littoral Sediment Budget at Bolinas Inlet
PWA Ref. #: 1686.03

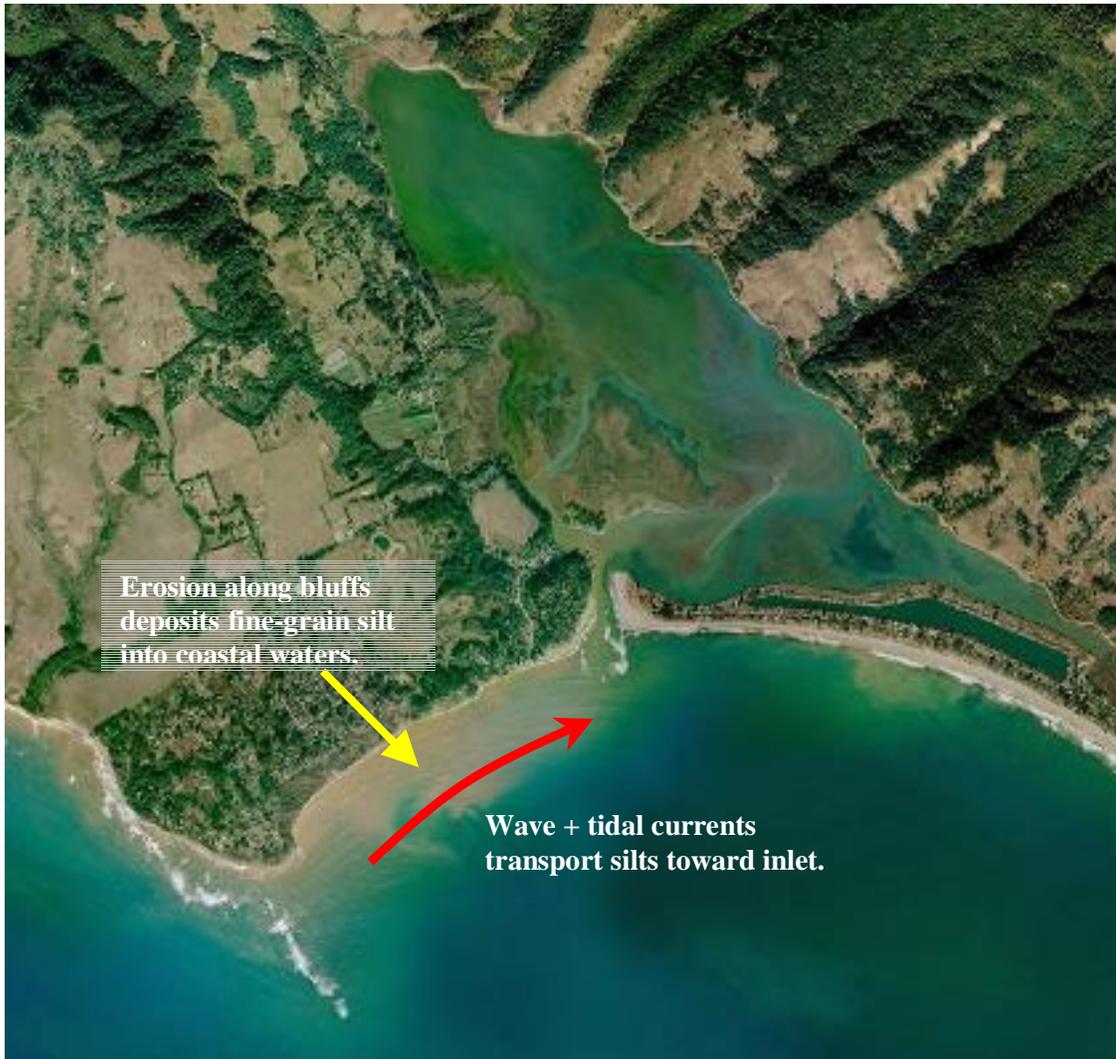
figure 3
Conceptual Littoral Sediment Budget at Bolinas Inlet

Erosion and Transport at Bolinas Bluffs

1. Bluff erosion along Bolinas. Wave attack along the bluffs west of Bolinas delivers sediment to the littoral zone that is subsequently transported toward the inlet by wave and tidal currents (Figure 3). These bluffs, which are primarily composed of erodible Monterey Shale, are receding at a rate of about 1.5 ft/yr, resulting in approximately 1 million cubic feet (mcf) per yr (or about 37,000 cubic yards per year (CY/yr) of sediment introduced to the littoral zone (Ritter, 1973). Wave action and currents sort the sediment deposited at the base of the bluffs, leaving coarse-grain sands along the beaches and transporting a portion of the eroded material toward Bolinas Lagoon and a portion into deeper water in Bolinas Bay.

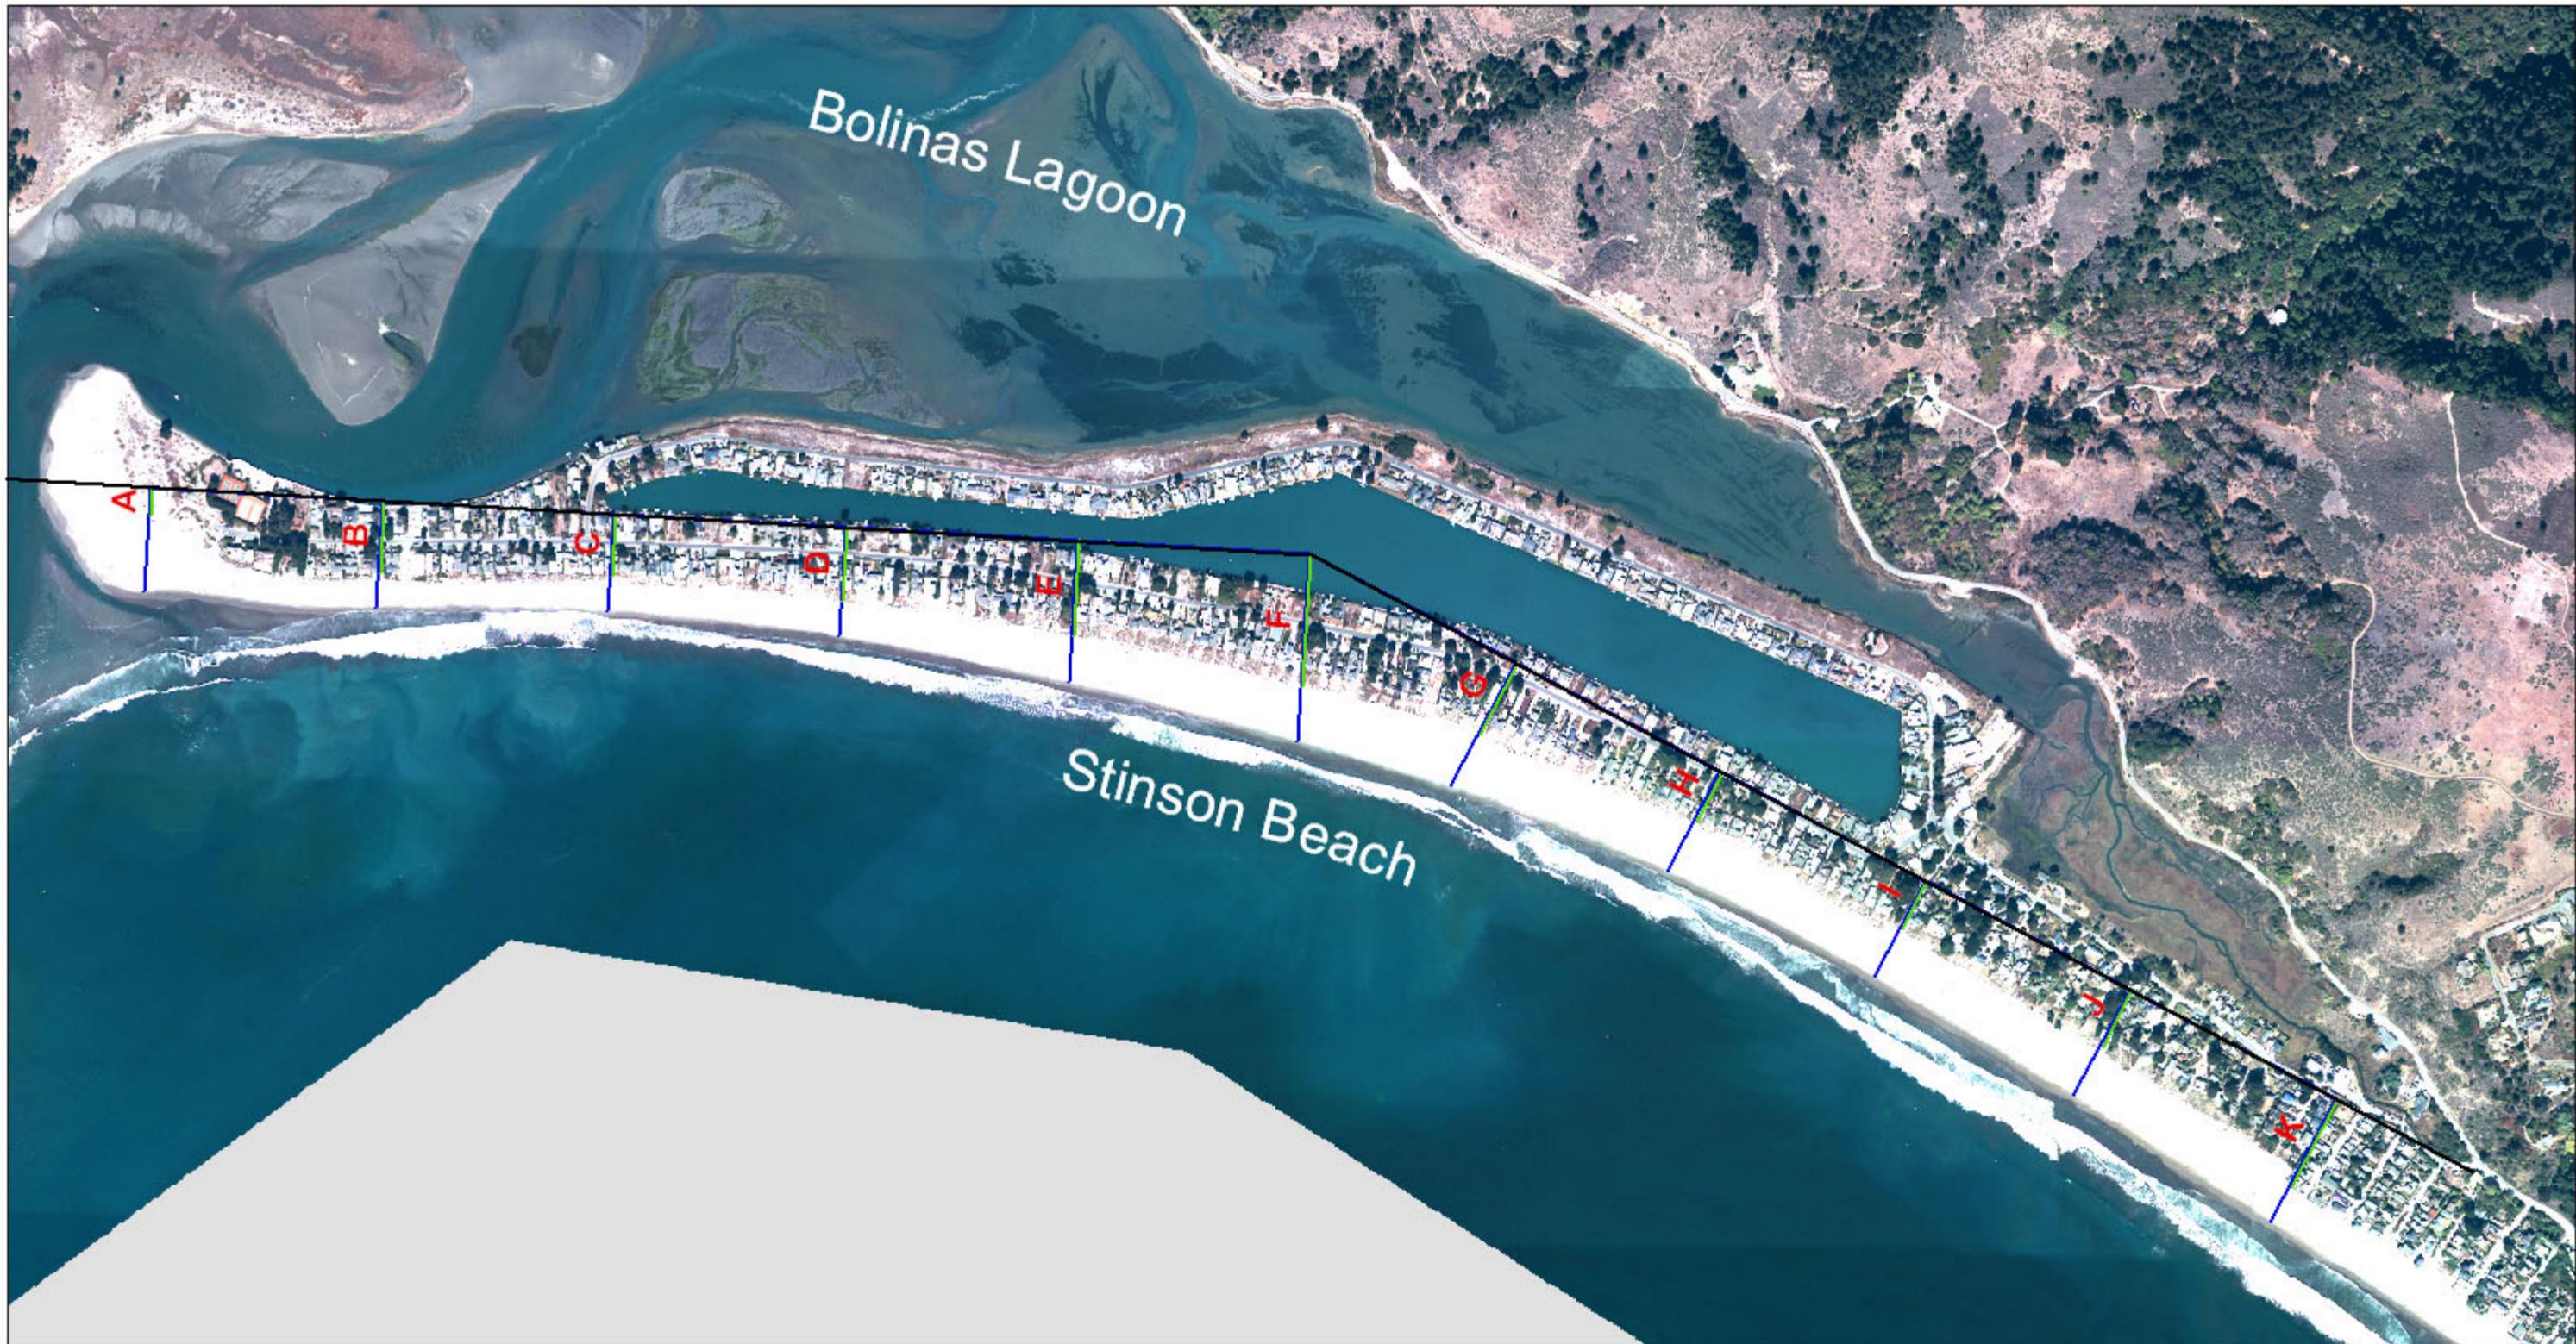
figure 5

Note: Beach Width is defined as the distance between the Average High Water Line and the Vegetation Line

Conceptual Littoral Sediment Budget at Bolinas Inlet
 Shoreline Analysis- Transect Configuration

In order to quantify beach dynamics, PWA staff reviewed eleven aerial photographs collected from 1942 to 2001 using GIS tools. PWA staff digitized the average high water line for each photograph by examining differences in reflectance and micro-topography such as wind-rippled sand. Beach width was then computed as the distance from the average high water line to the vegetation line for the 10 transects shown in Figure 5¹. Beach widths measured at each transect are plotted in Figure 6, while Figure 7 shows the average, minimum and maximum beach width measured along the beach for each photograph. As demonstrated by these results, most of the variance in beach width is within the typical seasonal variability reported by others (Johnson, 1973) or occurred after strong El Nino winters. Beach recovery appears to be complete, even after intense El Nino years. Overall, these results do not reveal any long-term trend in beach width that can be attributed to armoring of the Seadrift, suggesting that most of the eroded sand is temporarily stored in offshore bars and later transported back onto the beach.

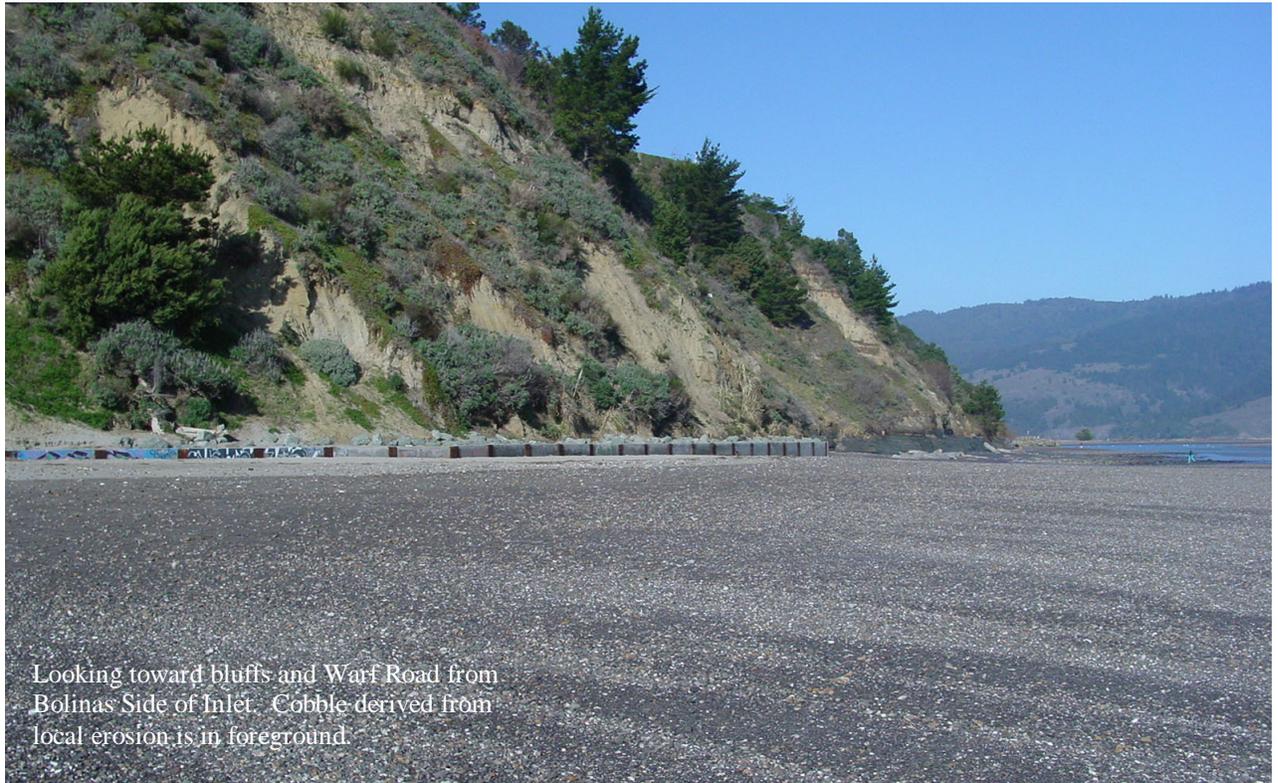
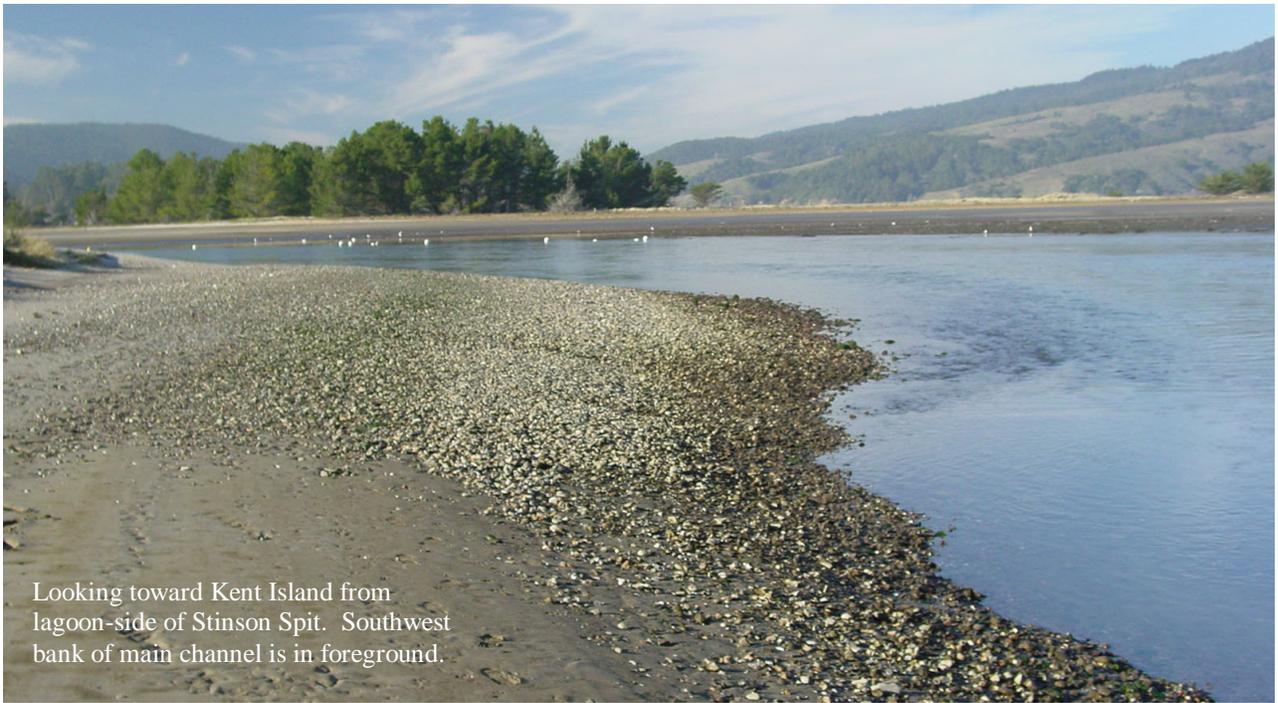
figure 8
Conceptual Littoral Sediment Budget at Bolinas Inlet

Cobble Sediment at Inlet

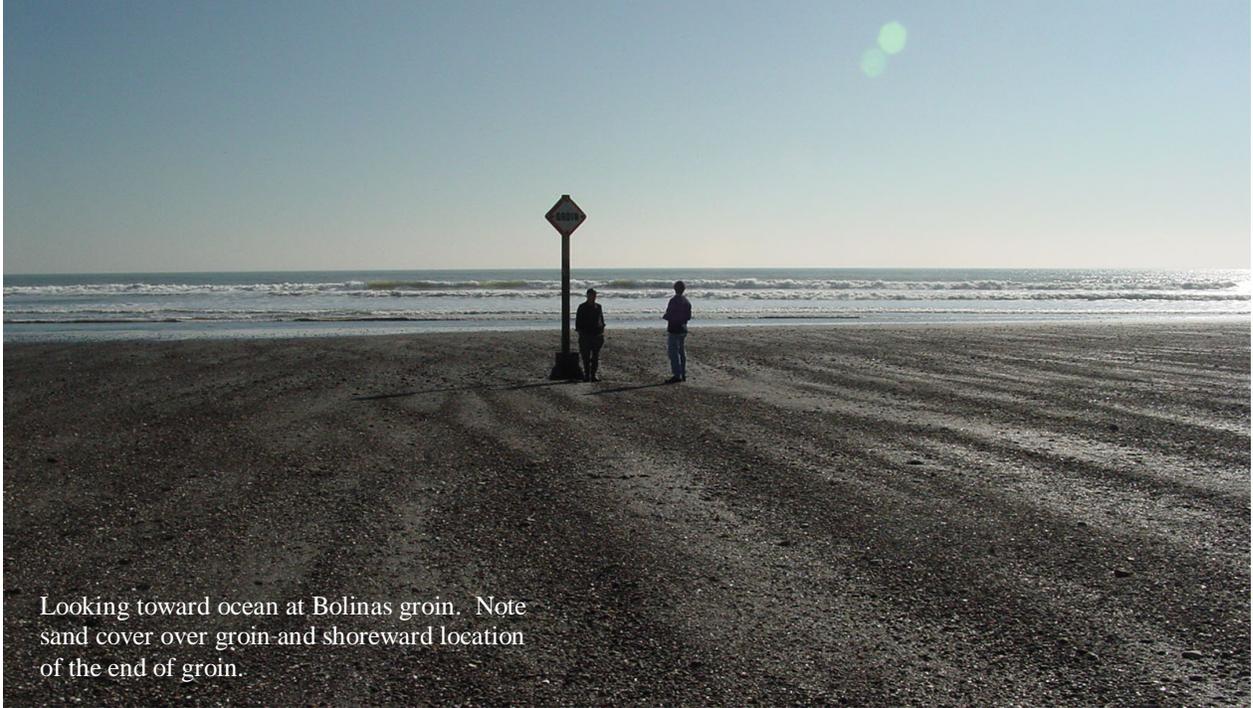
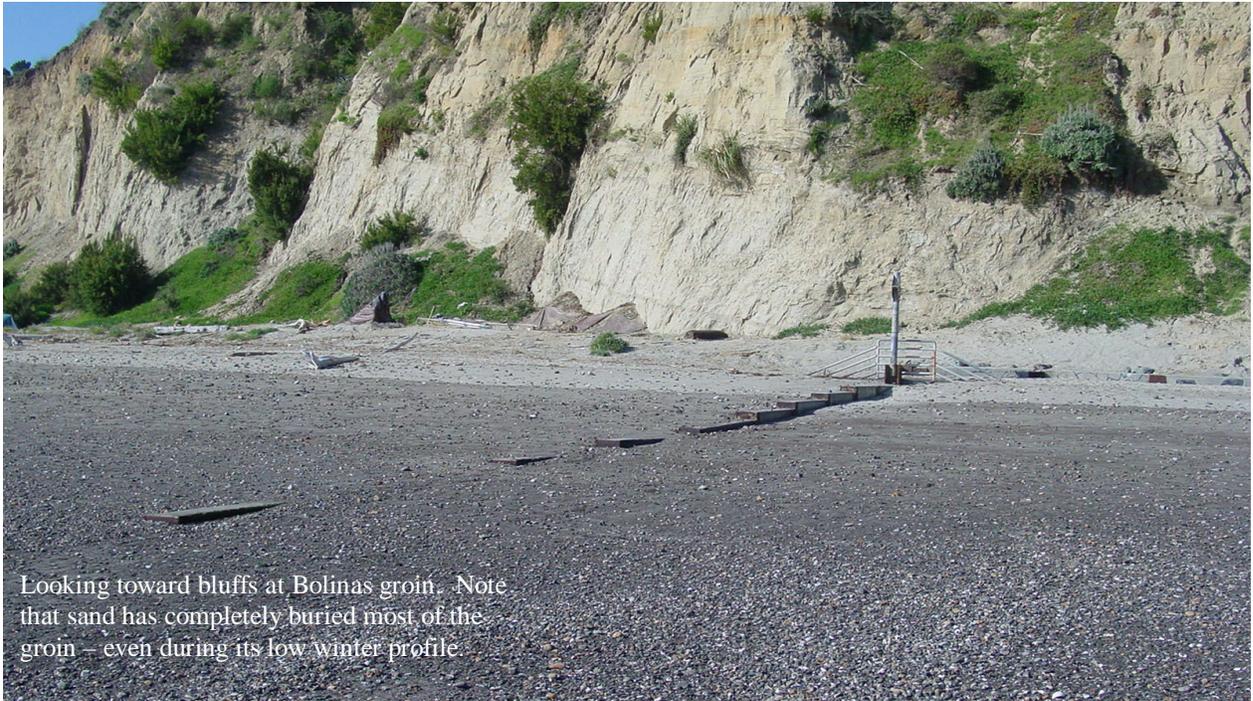
figure 9
Conceptual Littoral Sediment Budget at Bolinas Inlet

Looking toward ocean at Bolinas groin. Note sand cover over groin and shoreward location of the end of groin.

Looking toward bluffs at Bolinas groin. Note that sand has completely buried most of the groin – even during its low winter profile.

Bolinas Groin Buried by Sand

- A properly functioning Bolinas groin partially traps longshore drift directed toward the inlet and is effective at increasing the size of Brighton Beach. However, the effects of the groin on coastal processes are limited due to its relatively low elevation and short length. Wave breaking around the tip of the groin and inundation at high tide demonstrate that sand bypasses the structure once the beach builds-up to its equilibrium size.

The effects of the Bolinas groin on longshore transport is evident from historical observations; from the late 1880's to the present day, the presence of an intact structure has been increasing the size of Brighton Beach effectively by impounding sand moving toward the inlet. The relatively short length and low elevation of the groin limit the effects of the structure, with sand bypassing the structure once the beach builds up to its equilibrium profile (Figure 9). Assuming a beach length and width of 600 ft and 240 ft, respectively, and 7 ft of vertical accumulation, the groin traps approximately 1 mcf of sand. The localized trapping of sand probably has a limited influence on the pattern of sand transport near the inlet by deflecting the longshore drift slightly offshore, with probable negligible effects on littoral sediment inflows to the lagoon.

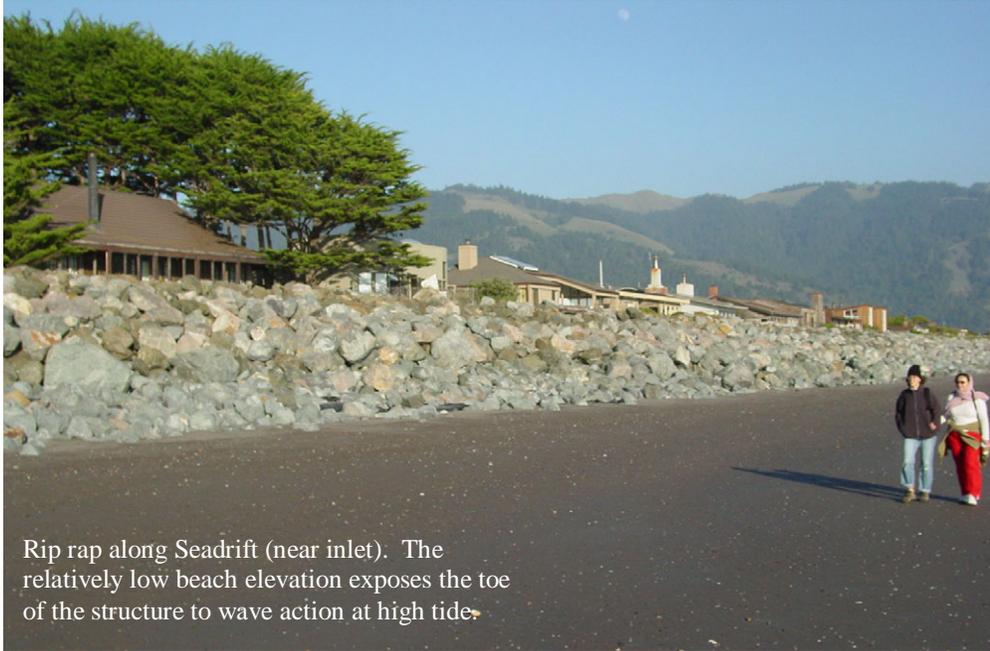
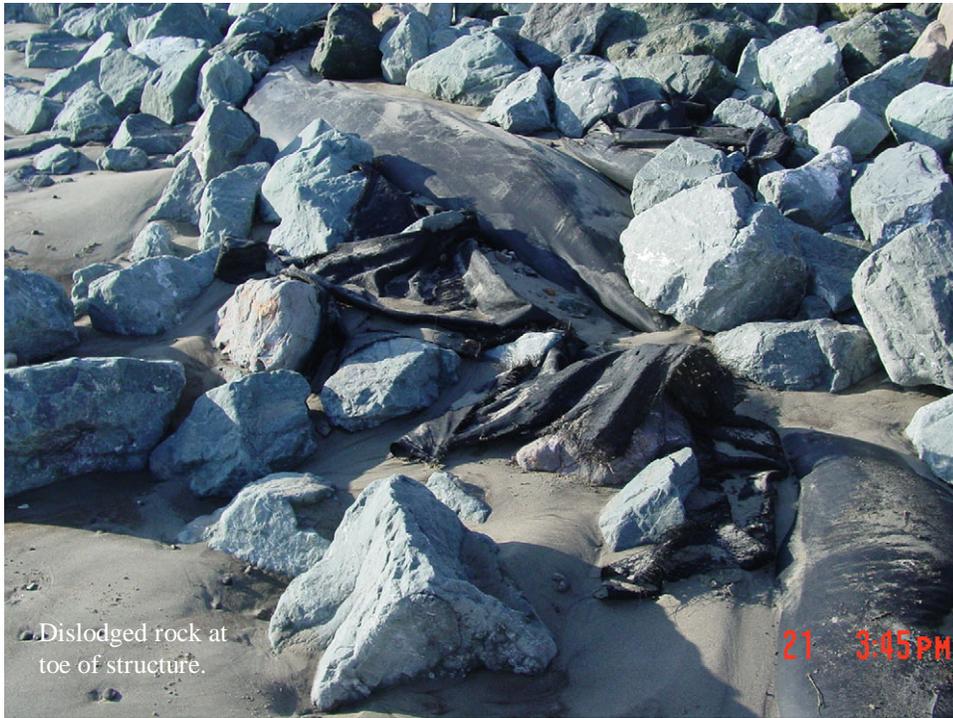
figure 10
Conceptual Littoral Sediment Budget at Bolinas Inlet

Rip rap along Seadrift (near inlet). The relatively low beach elevation exposes the toe of the structure to wave action at high tide.

Dislodged rock at toe of structure.

Dislodged Rock at Rip Rap

- Waves reflected from riprap along Seadrift Beach focus wave power along the nearshore and have the potential to lower the equilibrium beach profile. A lower beach elevation increases wave attack on the structure, especially at its toe where PWA staff observed dislodged rocks during a field visit in January 2004. Although a mechanism for reducing longshore transport has been identified (i.e., lowering of the beach by wave focusing), data reviewed by PWA do not reveal any change in beach morphology due to installation of the riprap, and its effects on existing rates of longshore transport are expected to be minor.

The original revetment was constructed using stone 2 to 3 ft in diameter ($\frac{1}{2}$ to $1\frac{1}{2}$ tons in weight) and placed at a 2.5:1 (horizontal:vertical) slope, with a crest elevation of +17.5 ft MLLW and a toe elevation of approximately +7 ft MLLW. A 1998 visual inspection of the structure found that armor stone had become dislodged or subsided at numerous areas along its entire length, exposing bare earth or the smaller engineers rock (6 to 12 inches in diameter) at steep grades. In response to the deteriorated condition of the armor, approximately 5,000 tons of stone (about 17%

of the original amount) were placed along the revetment in 2004 to re-establish its original design configuration. Rock placed during the 2004 maintenance averaged 2.85 ft in diameter (1¼ tons).

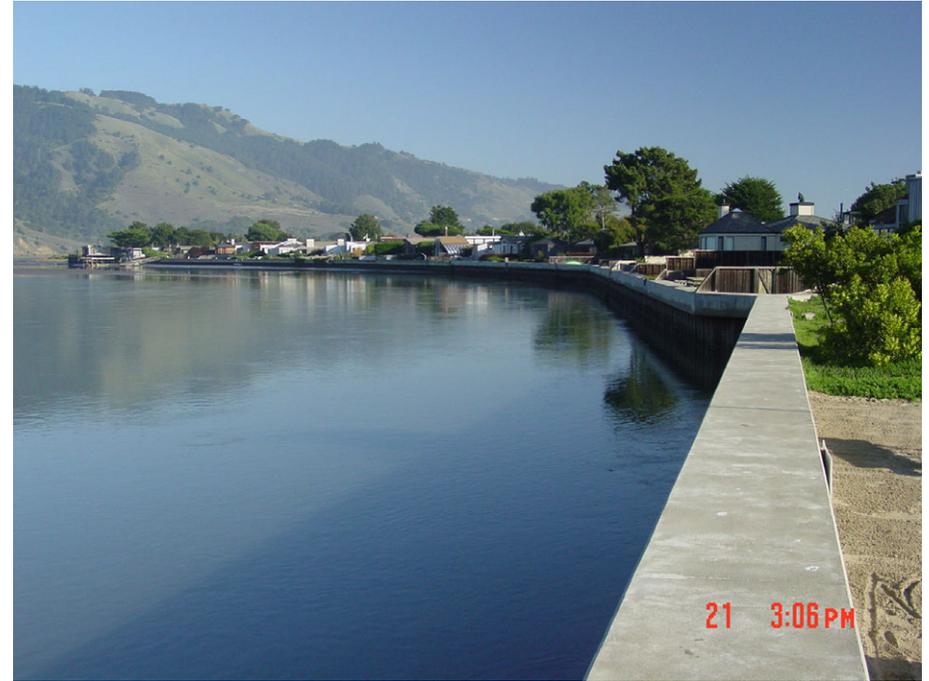
figure 11
Conceptual Littoral Sediment Budget at Bolinas Inlet

Note: End of bulkhead (looking south).
 Source: PWA (Jan 21, 2005)

Bulkhead on at Seadrift

- Bulkheads inside Bolinas Lagoon. The first bulkhead constructed along the lagoon side of Stinson Spit consisted of approximately 675 linear ft of timber and asbestos sheet pile wall. Strong tidal currents along the main channel of the lagoon eroded this structure over the years, requiring reinforcement by placing vertical timber sheet lagging along the waterside of the structure. Failure of the asbestos and timber bulkhead continued, and in 1998 the structure was completely replaced by the interlocking steel sheet pile wall shown in Figure 11. During the replacement, the toe of the bulkhead was extended from –6 ft MLLW to an elevation of approximately –21 to –27 ft MLLW to prevent tidal currents along the main channel from undermining this part of the structure.

Construction and maintenance of the bulkhead has reduced the migration of the main tidal channel in Bolinas Lagoon and created a more ‘rigid’ system. Shoaling along the Bolinas Channel over the past few decades has focused all of the tidal flows through the main channel, increasing its scour potential and modifying its natural equilibrium planform. In an unconstrained channel system (i.e., without the bulkhead) it is possible that the main channel could breach the spit at a new location. However, the westward net longshore transport along Seadrift Beach would re-establish the inlet at its present location where wave exposure is less due to sheltering from Duxbury Reef. Based on the relatively large and unidirectional longshore
